**Flood Control Project Maintenance  
Levee Inspections**

**Fall 2016 Levee Maintenance Deficiency Summary Report**

**Sacramento River Basin**

| <b>MA0005</b> | Overall LMA Rating | Total LMA Miles | * Overall LMA Threshold Percent is less than 10.00%; however, U Rated Miles are present, so the Overall LMA Rating is M instead of A. | | | | | |
|--|---|---|---|---|---|---|---|---|
| <b>Sutter Maintenance Yard Maintenance Area 0005</b> | <b>M *</b> | <b>32.84</b> | | | | | | |

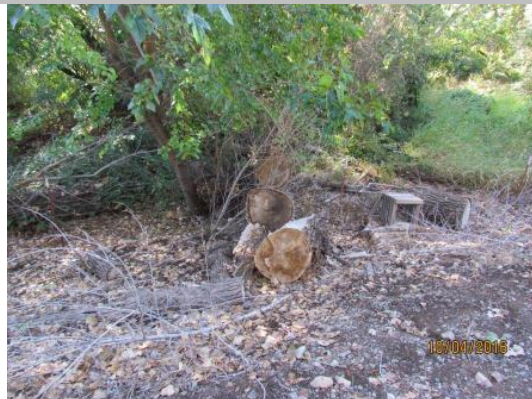
Photo 1 of 1 : FA\_2016\_MA0005\_196\_45\_20161014\_00058.jpg

View of the wood logs on the landside slope.

| Remove wood logs from the waterside slope and trim trees to at least five feet above the levee slope. | | | | | |

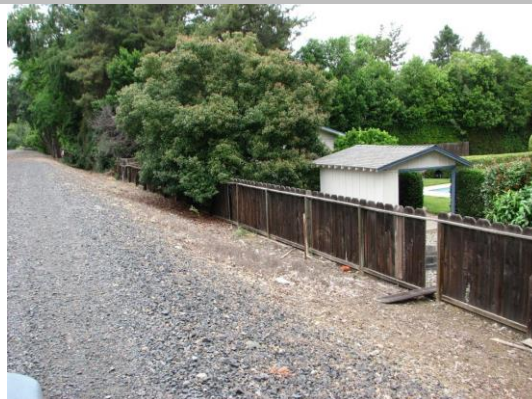
Photo 1 of 1 : FA\_2016\_MA0005\_196\_42\_20160823\_00022.jpg

View of the wood plank fence at the landside toe.

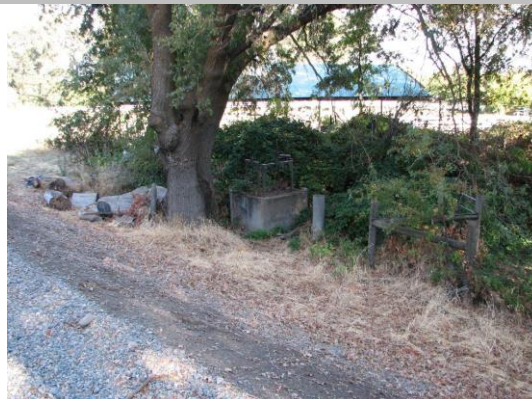
Photo 1 of 2 : UCIP\_FA\_2016\_50841\_67928.jpg

FS\_ID:50841  
DS\_ID:1615  
EP\_NO: N/A  
Repair Type: Non-Urgent  
Crossing Status: Found  
UCIP Comments: 11/15/2016 Abandoned- slide gate is opened and inoperable. Needs to be properly abandoned. (DWR Sutter Yard-AFreitag)5/9/2016 Abandoned crossing. Slide gate stem bent and wheel is missing.8/5/2015 Abandoned crossing. Slide gate stem is bent and gate is inoperable. Needs to be properly abandoned.12/8/2014 Same as last inspection.6/11/2014 Same as last inspection.11/20/2013 Same as last inspection.5/29/2013 Same as last inspection.10/30/2012 Pipe appears to be abandoned. Slide gate open and inoperable. Pipe should be properly abandoned. FIELD\_STRUCT\_DESC: 30-inch corrugated metal irrigation pipe (siphon) through the levee, 10.5 feet below the crown. Slide gate in a corrugated metal riser on the waterside (WS) slope. Concrete distribution box on the landside (LS) toe and concrete overflow and siphon box at the edge of berm. [Additional Reference(s): DWR Levee Log, 1990. USACE Sacramento O&M Manual 516, April 1960 (Station 368+17)].

Concrete distribution box on LS toe.

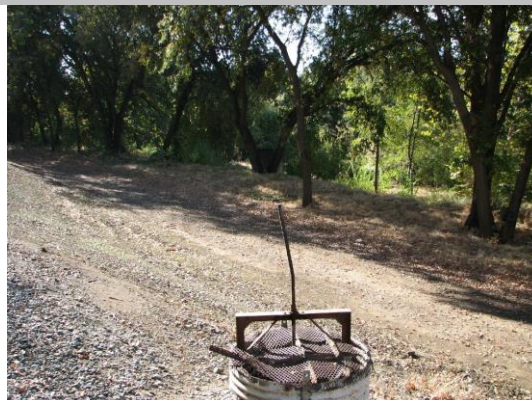
Photo 2 of 2 : UCIP\_FA\_2016\_50841\_67927.jpg

CMP riser with slide gate on WS shoulder. Notice bent screw in open position.

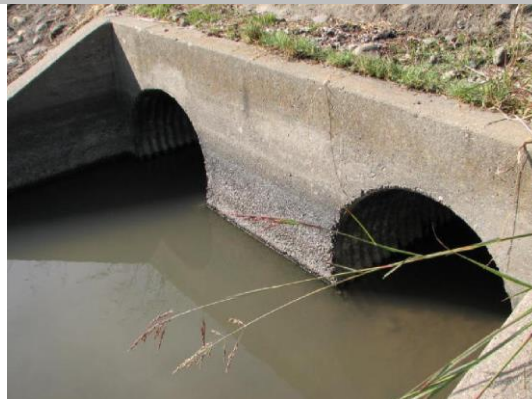
Photo 1 of 2 : UCIP\_FA\_2016\_50848\_67941.jpg

| FS_ID:50848<br>DS_ID:1620<br>EP_NO: N/A<br>Repair Type: Non-Urgent<br>Crossing Status: Found<br>UCIP Comments: 11/15/2016 Abandoned. Needs cover for the standpipe. (DWR Sutter Yard- AFreitag)5/9/2016 Abandoned pipe. Needs a cover for the standpipe.8/5/2015 Abandoned crossing. Covers need to be made for tops of standpipes to prevent falls.12/8/2014 Same as last inspection.6/11/2014 Same as last inspection.11/19/2013 Same as last inspection.5/29/2013 Same as last inspection. Land owner said pipes are abandoned and no longer used. Covers should be made for top of standpipe to prevent falls. Pipes should be properly abandoned.10/30/2012 Pipe 1/2 filled with soil at slide gate end.<br>FIELD_STRUCT_DESC: *ABANDONED* 1 of 2: 36-inch drainage pipe through the levee, 11 feet below the crown. Slide gate in a 54-inch corrugated metal riser on the waterside (WS) slope. Concrete "U" headwall on the landside (LS). [Additional Reference(s): DWR Levee Log, 1990. Sacramento O&M Manual 516, April 1960 (Station 470+00)].<br>FS Date: 11/21/2016 1:39:16 PM | | | | | |

Headwall at LS toe.

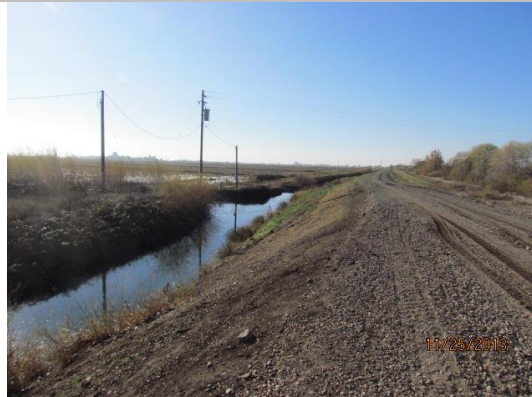
Photo 1 of 1 : FA\_2016\_MA0005\_196\_55\_20160823\_00025.jpg

View of the irrigation ditch along the landside toe.

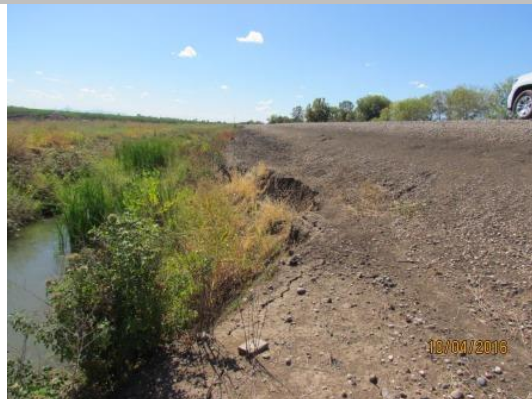
Photo 1 of 2 : FA\_2016\_MA0005\_196\_56\_20161014\_00068.jpg

View of the landside toe erosion.

| E2 : Schedule repair of erosion site prior to the next inspection. | | | | | |

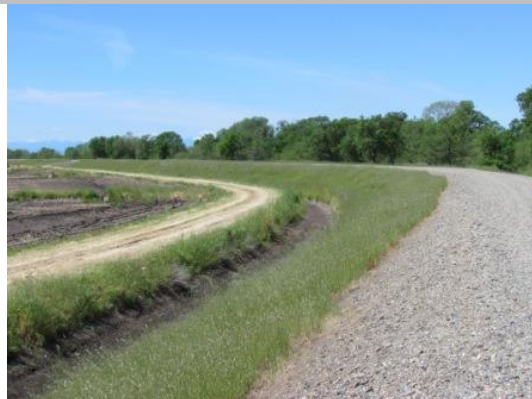
Photo 1 of 1 : FA\_2016\_MA0005\_196\_5\_20160823\_00003.jpg

View of the agricultural ditch along the landside toe.

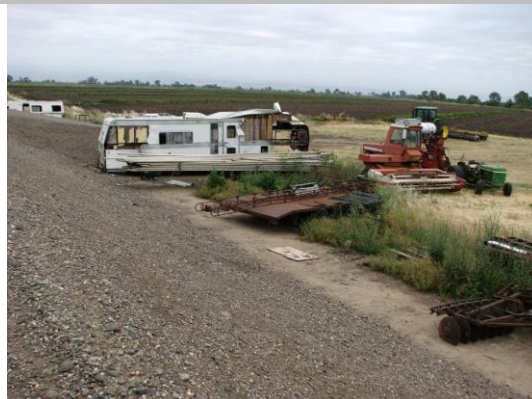
Photo 1 of 1 : FA\_2016\_MA0005\_196\_26\_20160823\_00008.jpg

| Abandoned motorhomes and farm equipment. | | | | | |

5/5/2016: Remove abandoned motorhome and equipment from L/S toe.

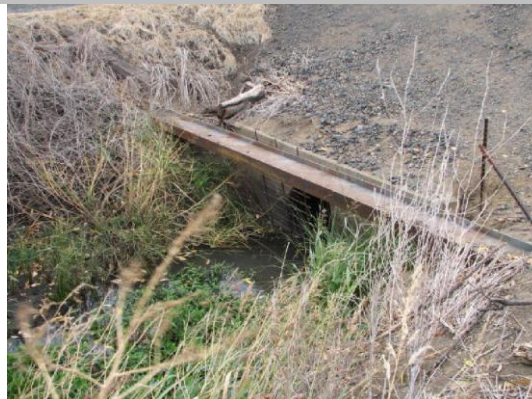
Photo 1 of 2 : UCIP\_FA\_2016\_50891\_68033.jpg

Headwall at inlet on LS toe.

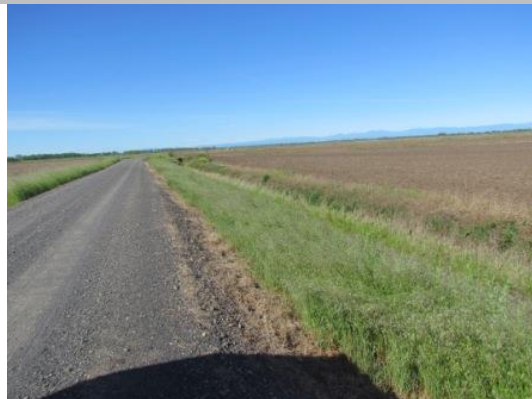
Photo 1 of 1 : FA\_2016\_MA0005\_197\_1\_20160823\_00001.jpg

View of the agricultural ditch along the landside toe.

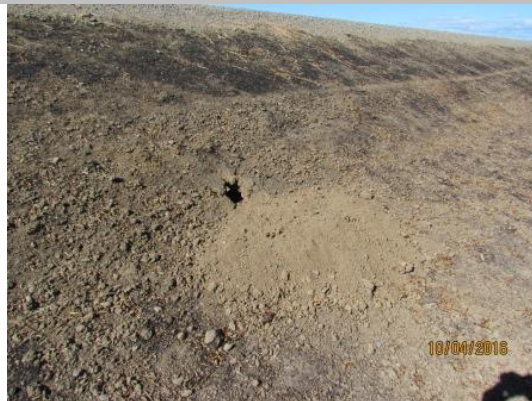
Photo 1 of 1 : FA\_2016\_MA0005\_197\_50\_20161014\_00070.jpg

View of the rodent holes along the landside slope.

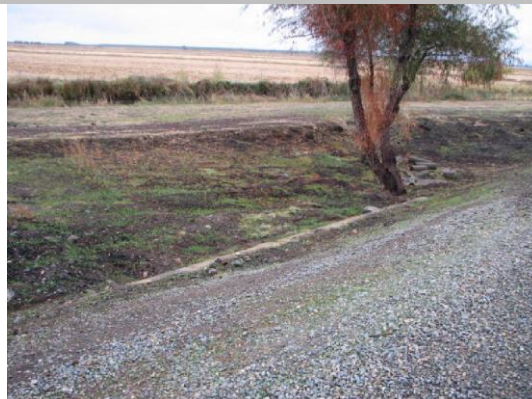
Photo 1 of 2 : UCIP\_FA\_2016\_48780\_68084.jpg

Concrete headwall on LS shoulder

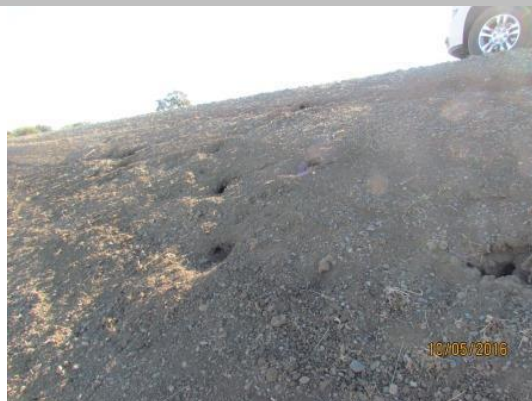
Photo 1 of 1 : FA\_2016\_MA0005\_197\_51\_20161014\_00071.jpg

View of the rodent holes along the landside slope.

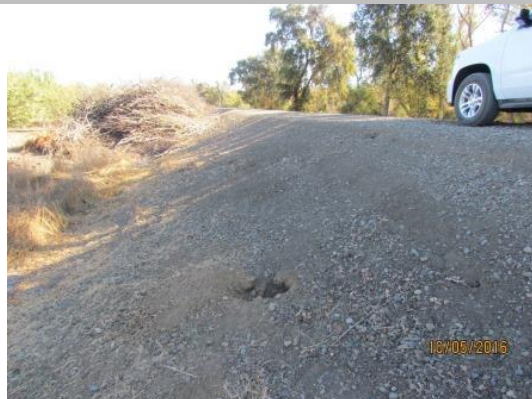
Photo 1 of 2 : FA\_2016\_MA0005\_197\_53\_20161014\_00073.jpg

View of the rodent holes along the landside slope.

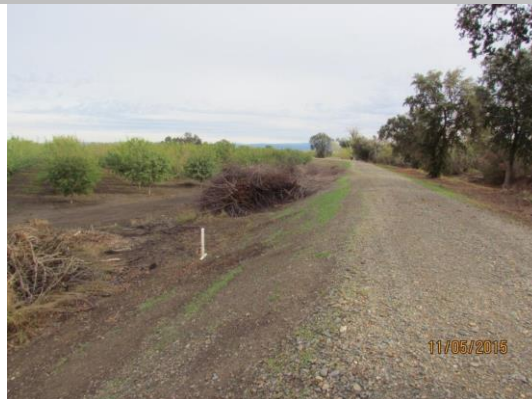
Photo 1 of 1 : FA\_2016\_MA0005\_197\_35\_20160823\_00013.jpg

View of the prunings along the landside slope.

| Remove the prunings from the landside slope. | | | | | |

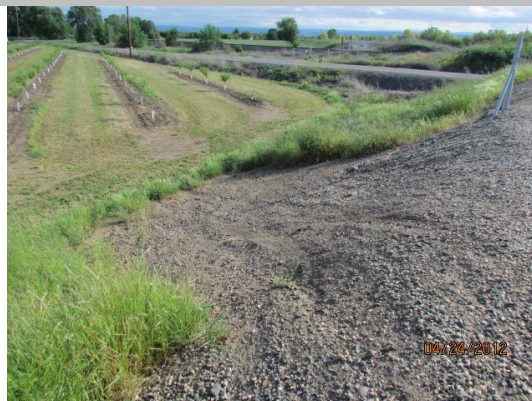
Photo 1 of 2 : FA\_2016\_MA0005\_197\_13\_20160823\_00005.jpg

View of the vehicle erosion along the slope.

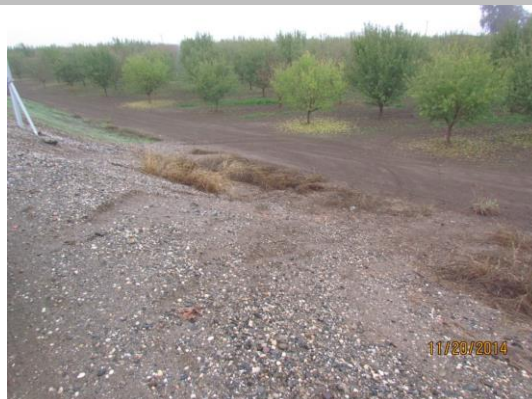
Photo 2 of 2 : FA\_2016\_MA0005\_197\_13\_20160823\_00006.jpg

View of the vehicle erosion along the landside slope.

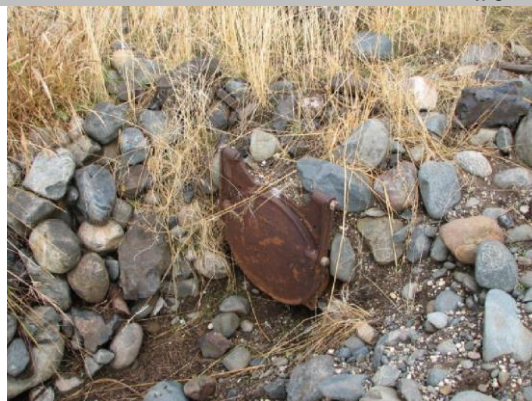
Photo 1 of 2 : UCIP\_FA\_2016\_50930\_68129.jpg

Flap gate at WS toe.

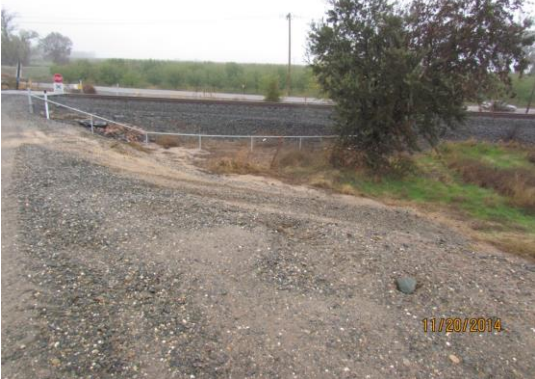
Photo 1 of 1 : FA\_2016\_MA0005\_197\_40\_20160823\_00016.jpg

View of the vehicle slope instability along the landside slope.

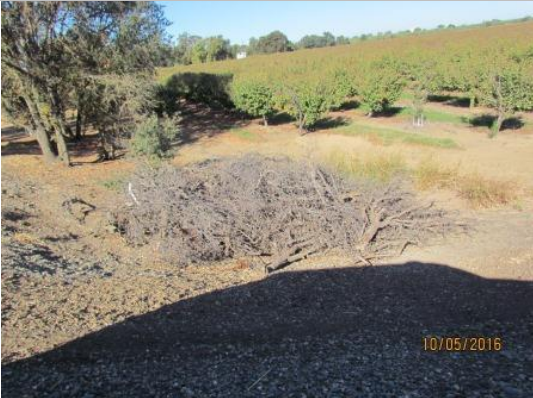
Photo 1 of 1 : FA\_2016\_MA0005\_197\_54\_20161014\_00076.jpg

View of the prunings along the landside toe.

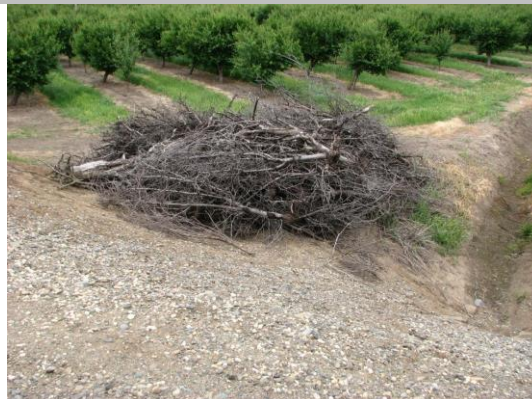
Photo 1 of 1 : FA\_2016\_MA0005\_197\_46\_20160823\_00021.jpg

View of the prunings along the landside toe.

| Remove the prunings from the landside slope. | | | | | |

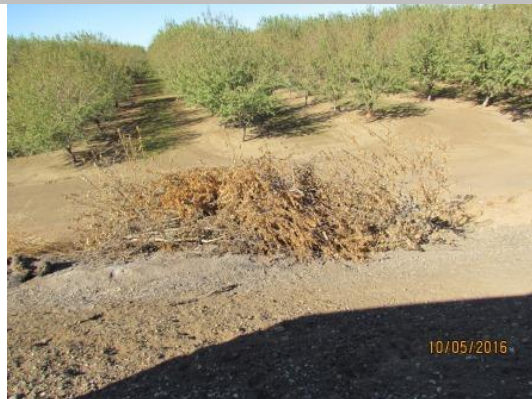
Photo 1 of 1 : FA\_2016\_MA0005\_197\_55\_20161014\_00078.jpg

View of the prunings along the landside toe.

| Remove the prunings from the landside slope. | | | | | |

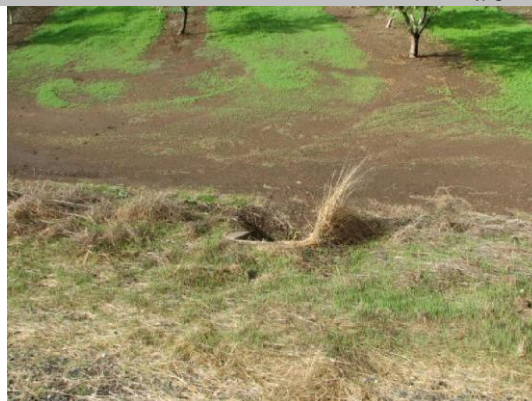
Photo 2 of 2 : UCIP\_FA\_2016\_50942\_68416.jpg

View of inlet on LS toe.

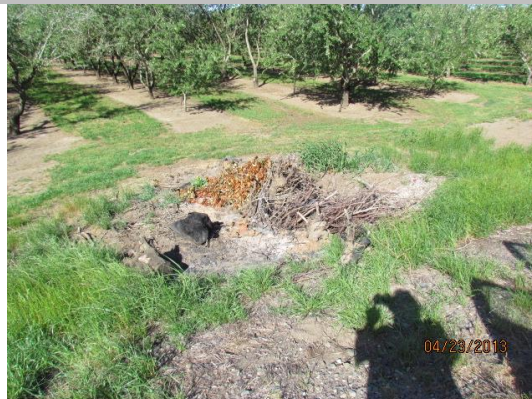
Photo 1 of 1 : FA\_2016\_MA0005\_197\_3\_20160823\_00002.jpg

View of the prunings along the landside toe.

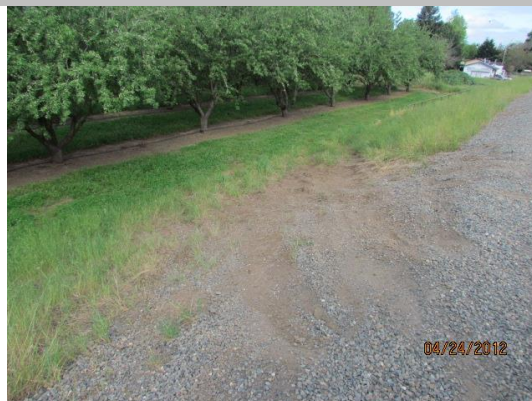
Photo 1 of 1 : FA\_2016\_MA0005\_197\_18\_20160823\_00008.jpg

View of the vehicle erosion along the slope of the levee.

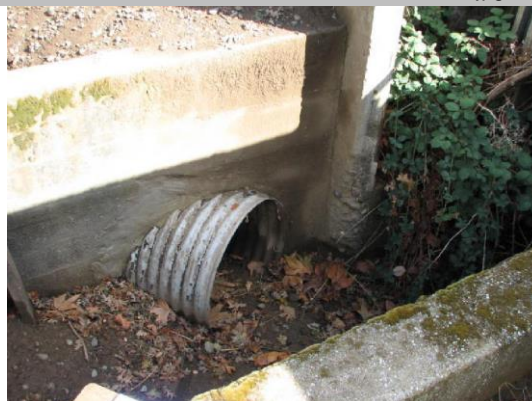
Photo 1 of 2 : UCIP\_FA\_2016\_50948\_68436.jpg

Pipe at concrete distribution box on LS toe.

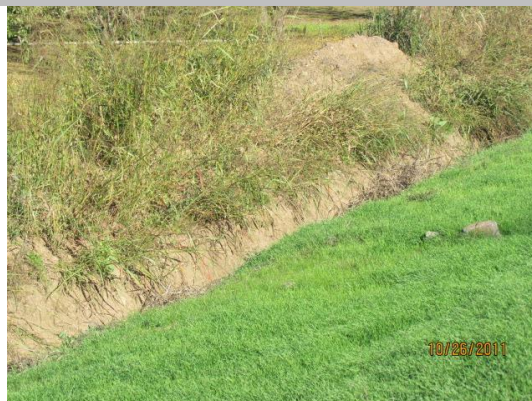
Photo 1 of 1 : FA\_2016\_MA0005\_197\_6\_20160823\_00003.jpg

View of the ditch along the Landside toe.

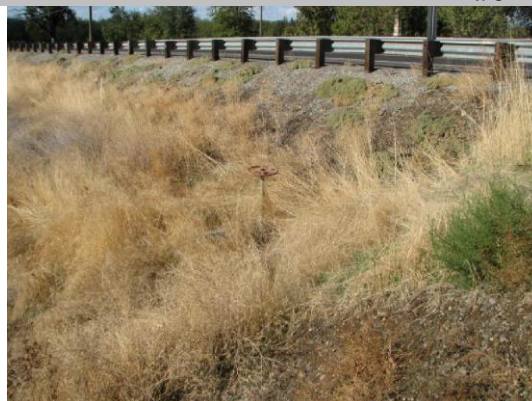
Photo 1 of 2 : UCIP\_FA\_2016\_50954\_68491.jpg

Slide gate at 4X4 concrete box on LS slope.

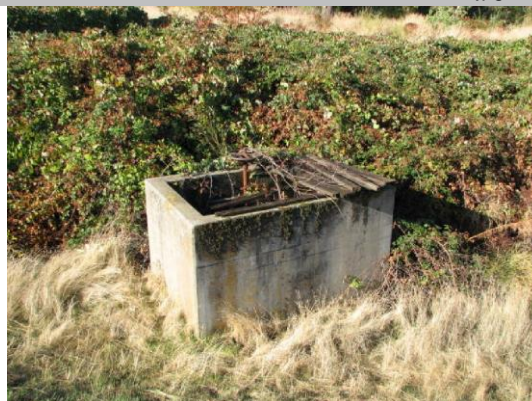
Photo 1 of 2 : UCIP\_FA\_2016\_50967\_68570.jpg

Concrete distribution box with slide gate on LS toe.

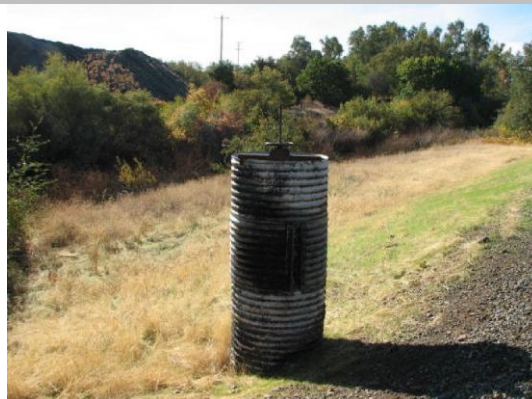
Photo 1 of 2 : UCIP\_FA\_2016\_50968\_68572.jpg

CMP riser on WS slope with slide gate.

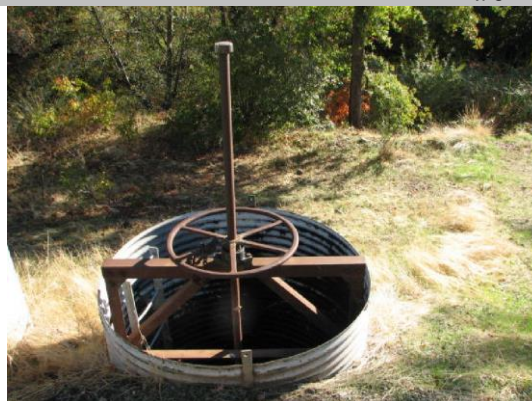
Photo 1 of 2 : UCIP\_FA\_2016\_50969\_68575.jpg

66-inch CMP riser on WS shoulder with slide gate.

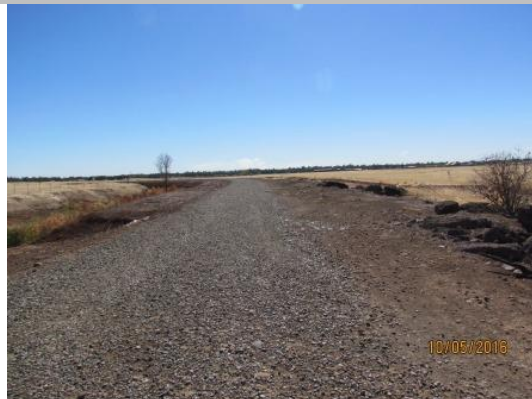
Photo 1 of 1 : FA\_2016\_MA0005\_198\_2\_20161110\_00001.jpg

| Levee crown is well maintained by the LMA. | | | | | |

View of the levee crown.
